## **C-5 A FUSELAGE STRESS ANALYSIS**

**Report No. TR-92-7**

**June 1992**

6. AUTHOR(S) Jatin C. Parekh Warren C. Gibson				
7. PERFORMING ORGANIZATION NAME(S) AND ADDRESS(ES) CSA Engineering, Inc. 2850 W. Bayshore Road Palo Alto, CA 94303			8. PERFORMING ORGANIZATION REPORT NUMBER ASIAC-TR-92-7

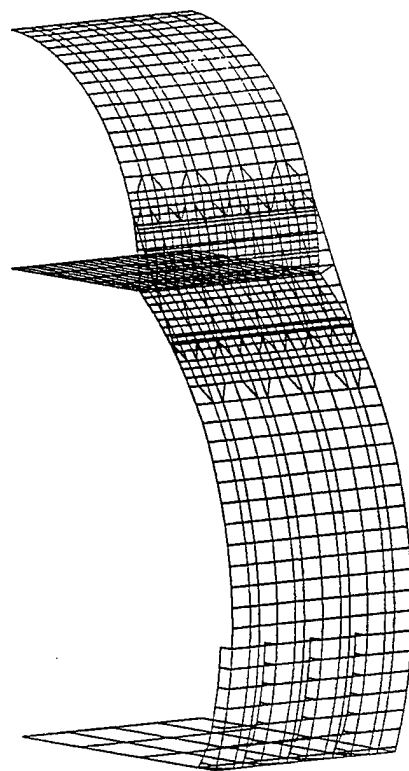
**Finite Element Model:** Since the fuselage section is symmetric, only half of the section was modeled. Furthermore, only the segment starting from fuselage station 604 (FS604) through FS684 was modeled. The model primarily consisted of beams and shell elements. The frames and stringers were modeled as beams and the fuselage skin panels were modeled with shell elements. The cargo floor, troop floor, and fairing panel were modeled with QUAD4 and BAR elements. In the model there are several ROD, SHEAR and RIGID elements which were included to replicate the Lockheed model. The FE model is shown in Figure 1.

Figure 1: Finite element model of the fuselage section
